# Manhole Inspection Summary

Manhole # S37C\_\_042MH

**Location** Address: **CITY IMPOUND LOT @ FALLSWAY** Cross Street: **E PLEASANT ST**

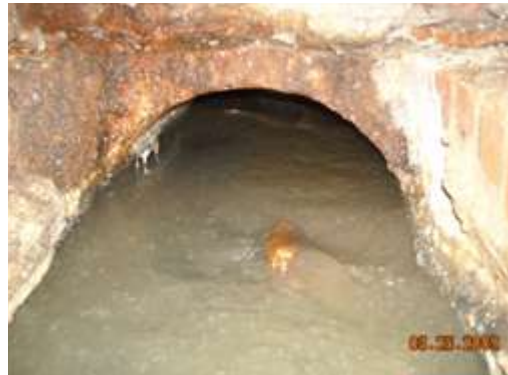
Defect 4

**Channel** Material: **Brick** ☐ Parged  
Channel Exposure: **Fully Open** Junc Dist: **0** nearest .5 ft. Azimuth: **0**  
Condition: ☐ Sound ☐ Cracked ☐ Root Intrusion ☐ Deteriorated ☐ Leaks ☒ **Debris**

DEBRIS IN CHANNEL

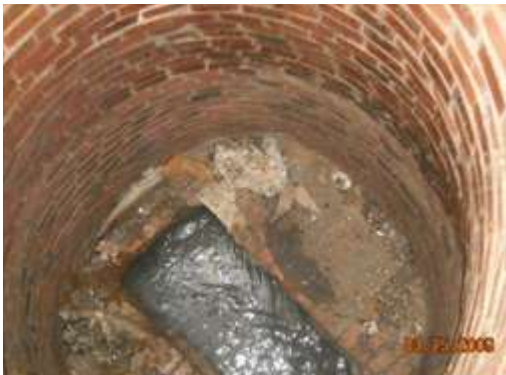
Defect 3

**Bench** ☒ Exists Material: **Brick** ☐ Parged  
Condition: ☐ Sound ☐ Cracked ☐ Root Intrusion ☐ Deteriorated ☐ Leaks ☒ **Debris**

DEBRIS ON BENCH

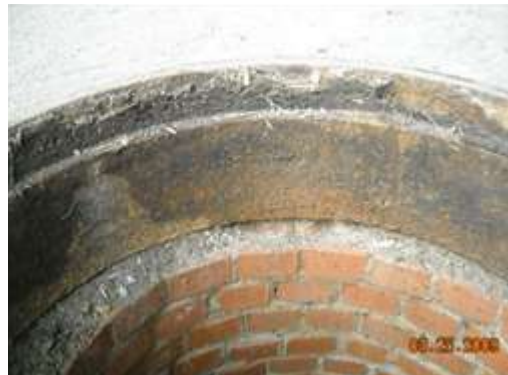
Defect 2

**Frame** Offset: **3** (in.) Condition: ☐ Sound ☐ Cracked ☒ **Leaks**

FRAME LEAKS

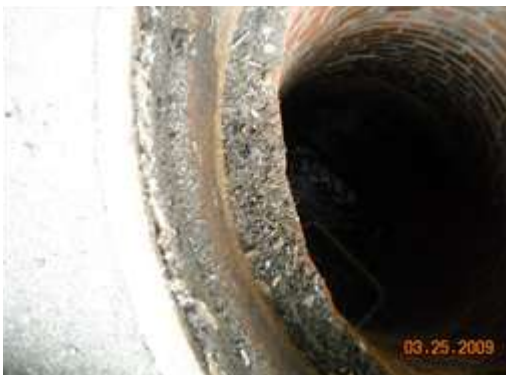
Defect 1

FRAME OFFSET

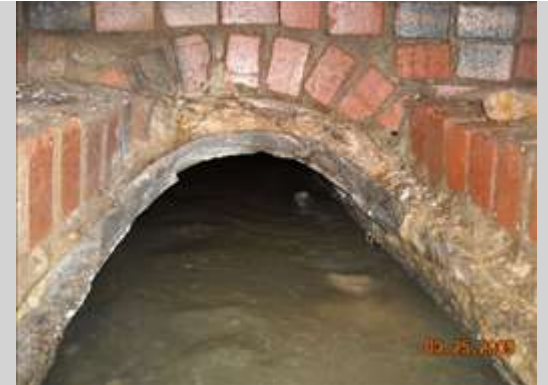
12 O'Clock Outflow

Pipe Height: **21.6** (in.) Rod and Bar (Angled)  
Pipe Material: **Clay** ☐ Pipe Lined  
Invert Depth: **13.10** (ft.) Flow Characteristics: **Fast**  
Deposits: ☐ None ☒ **Mud** ☐ Sludge ☒ **Debris** ☐ Grease  
Silt Depth: **8** (in.) Deposits Extent: **Medium**  
Infiltration: **None** Pipe Seal Cond: **Sound**

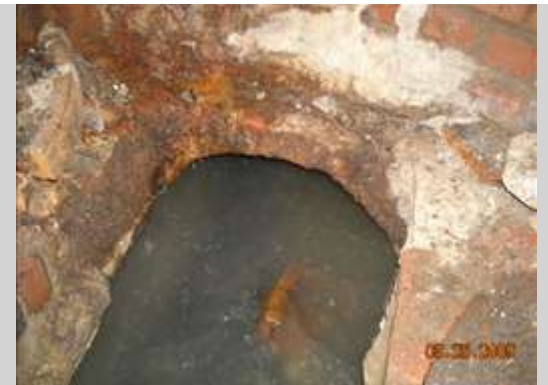
6 O'Clock Inflow

Pipe Height: **21.6** (in.) Rod and Bar (Angled)  
Pipe Material: **Clay** ☐ Pipe Lined  
Invert Depth: **13.00** (ft.) Flow Characteristics: **Fast**  
Deposits: ☐ None ☒ **Mud** ☐ Sludge ☒ **Debris** ☐ Grease  
Silt Depth: **8** (in.) Deposits Extent: **Medium**  
Infiltration: **Evidence** Pipe Seal Cond: **Sound**
